INTRODUCTION

1406 Anywhere Court, Leesburg, VA 20176.

Colonial Style Home.
Approximately 2400 Sq. Ft.
3 Years Old; 2 Story;
Full Unfinished Basement.

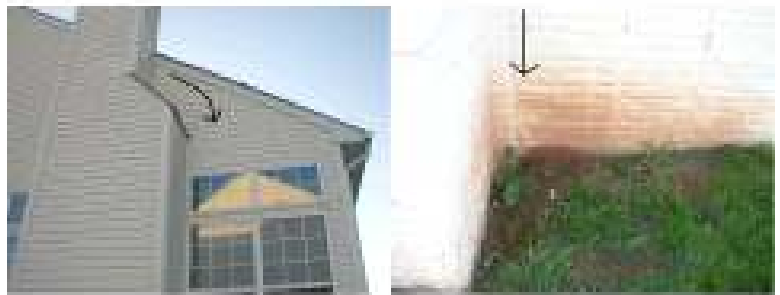
Mostly acceptable. Ideally you want to have a 6 inch drop within the first ten feet from the foundation. [CR] Some settlement has occurred on the right side where runoff from a very small section of roof falls. This depression should be filled in to prevent ponding near the foundation. Should settling in this area continue, we would recommend that the small roof above be fitted with a gutter and downspout to carry roof runoff further away from the house.

Settling from Roof Runoff

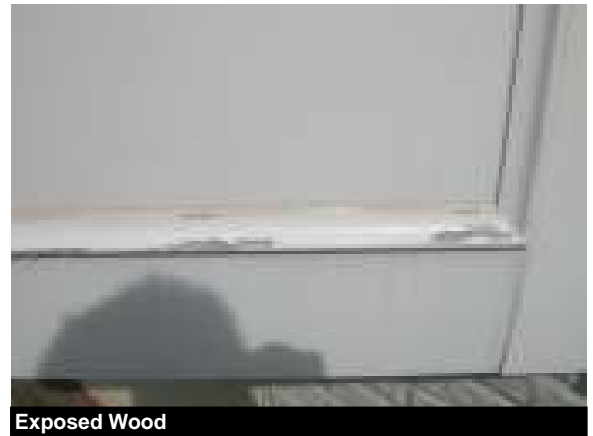
[CR] Small area of wood siding needs paint. Wood is currently exposed. We recommend referring to a trade specialist for further evaluation and corrections as required.

Exposed Wood

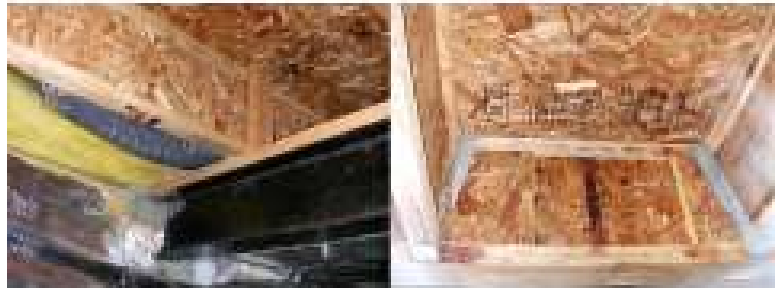
The visible floor joists are spaced 24" on center or less, and the subflooring is listed for 24" o.c. Condition is good.

I-Joists and Steel Beam

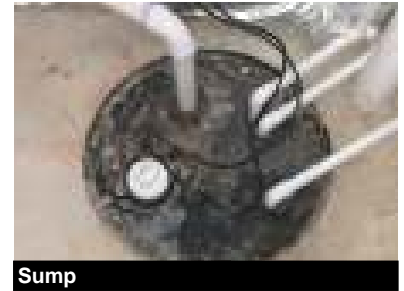
The visible areas of the floor and drainage appeared functional.

Sump

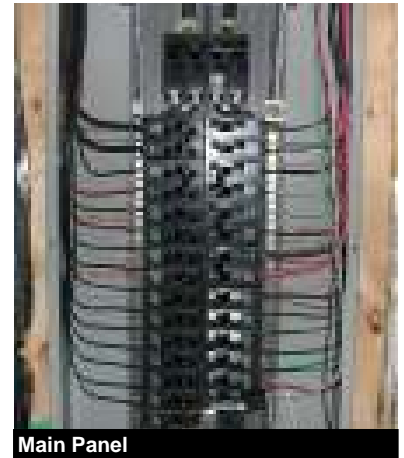
Main Panel location: basement. 120/240 volt system, rated at 200 amperes.

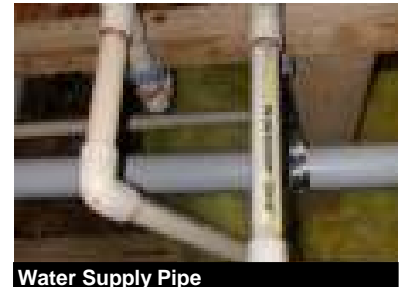
Materials: CPVC - Chlorinated polyvinyl chloride, Condition: Good.

Water Supply Pipe

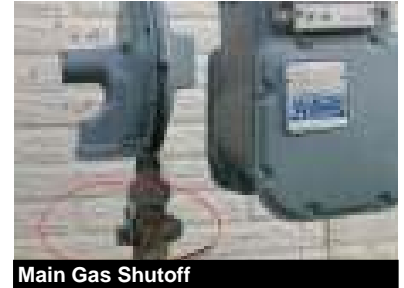
Where: The gas meter and shutoff valve are located at the left of the building.
The supply shutoff appeared functional. We do not operate these devices.

Main Gas Shutoff

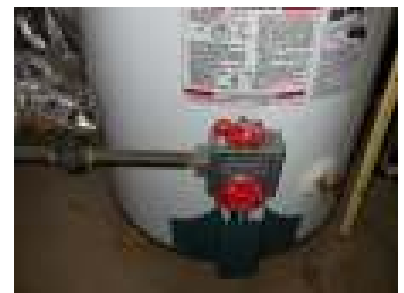
Brand: Rheem, 3 years old; 50 gallon, natural gas.

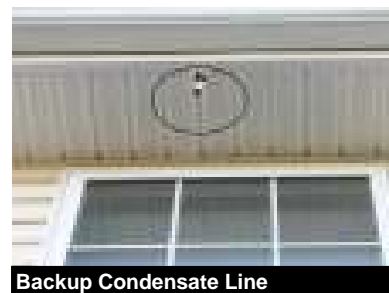
The secondary drain line discharge is shown in the picture here. Water should never drip from this discharge. If it does, the primary condensate line is blocked and should be repaired at once. Blocked condensate lines can cause considerable water damage to interior spaces.

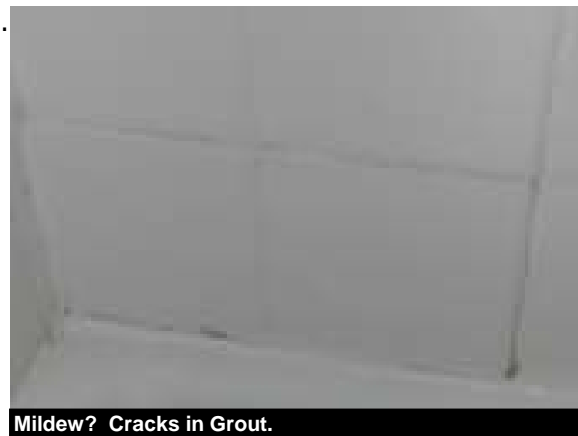
[CR] The grout and/or caulking was cracked, damaged or missing. These compounds are necessary to keep bathroom moisture from entering into the structure's interior spaces, and should be repaired and properly maintained as needed. Shower door is approved safety glass and is functional.

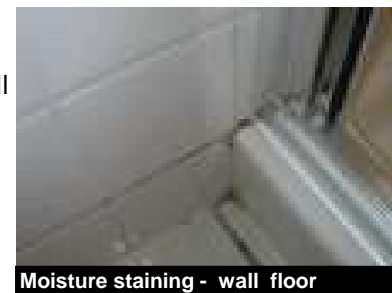
[CR] The grout in the floor tile closest to the shower has a tiny crack. Moisture meter readings indicate that the subfloor moisture is NOT elevated at this time. Recommend that this crack be sealed or otherwise repaired when the shower stall grout is fixed.

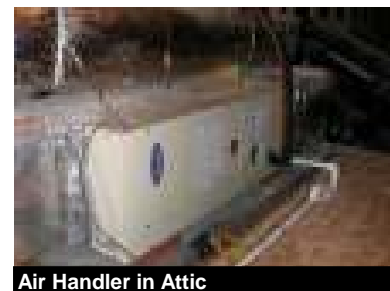
Yes. Worker access area is present. See photo.

Air Handler in Attic

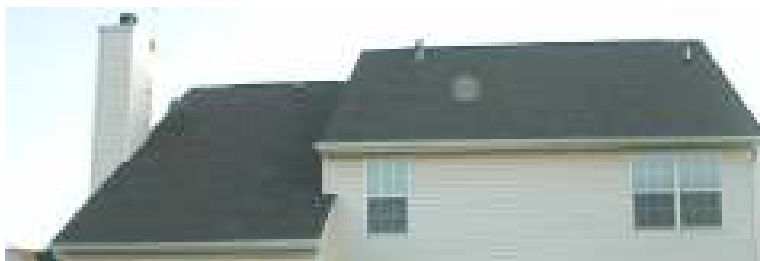
- a. [CR] There were a few shingles out of place that need to be set back in the proper position. □
